To: Jeff Cameron, Amy Blain – City of Longview **Date:** July 29, 2015

From: Stephen Booth, Michael Hallett, and Melinda Friedman – Confluence **Project:** Softening Alternatives & Baltimore Street Water Quality Evaluation

Cc: **Subject:** Home Water Quality Profiling - Final

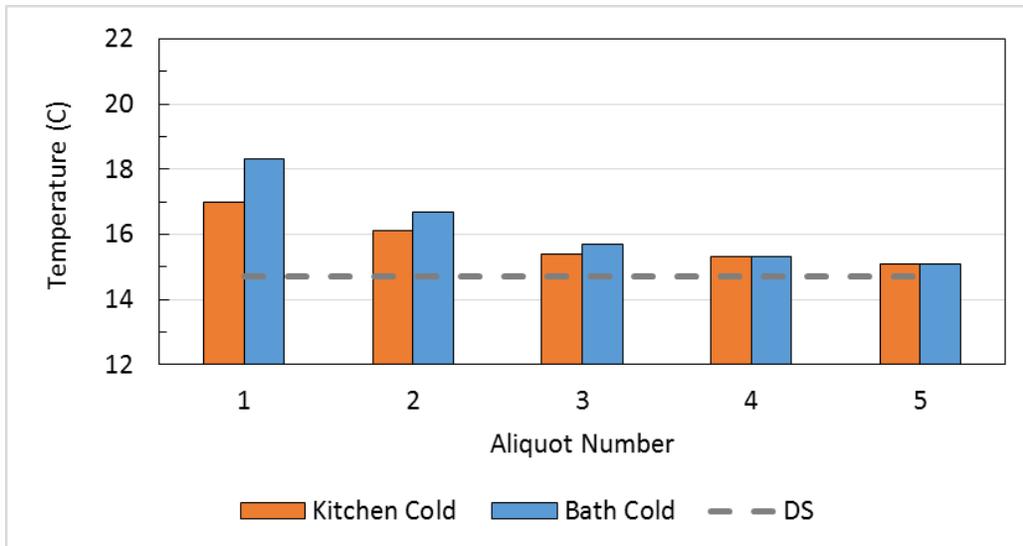
Temperature data for the sequential aliquots collected at the kitchen and bathroom cold taps in Home A are presented in Figure 1. The water temperature was initially somewhat higher in the bathroom and kitchen cold water taps compared to the distribution system. The water remained somewhat warmer compared to the distribution system for the first four aliquots. The temperature of the fifth aliquot was close to the distribution system water temperature.

Figure 1. Temperature data for Home A.

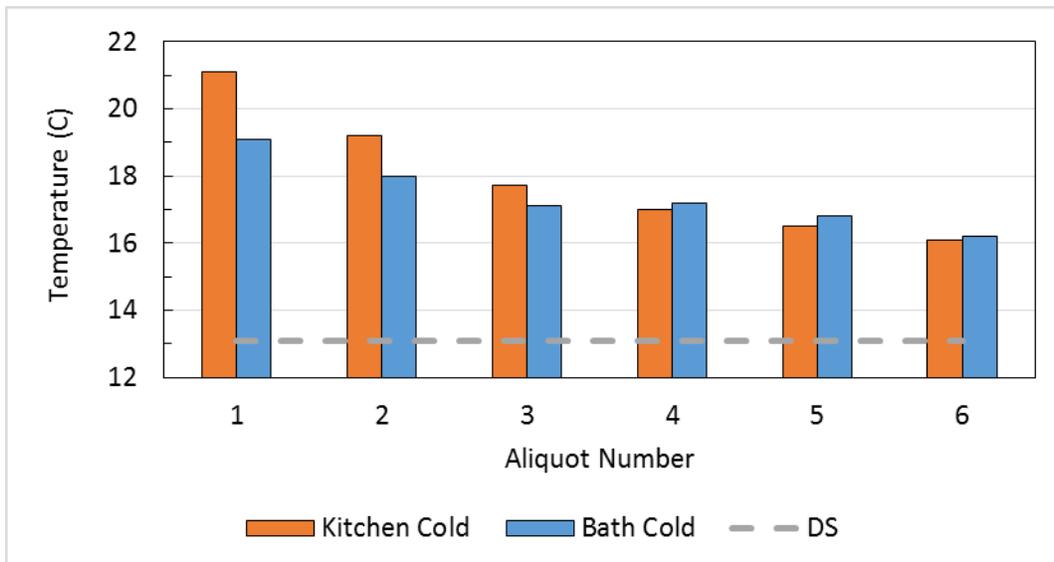
Temperature data for the sequential aliquots drawn from Home B are presented in Figure 2. Water temperatures were higher in Home B compared to Home A and the kitchen cold tap temperature was initially higher than that of the bathroom cold tap. Water temperatures for both taps stabilized at close to 16°C and remained above the temperature measured in the distribution system of 13.1°C. The lateral connecting this home to the system may have been longer than for Home A resulting in either a significantly longer time for the in-home cold water temperature to equalize with that of the system or a higher steady state temperature within the home than that of the system. The cold water temperature in the home remained above the distribution system temperature during this testing.

Figure 2. Temperature data for Home B.

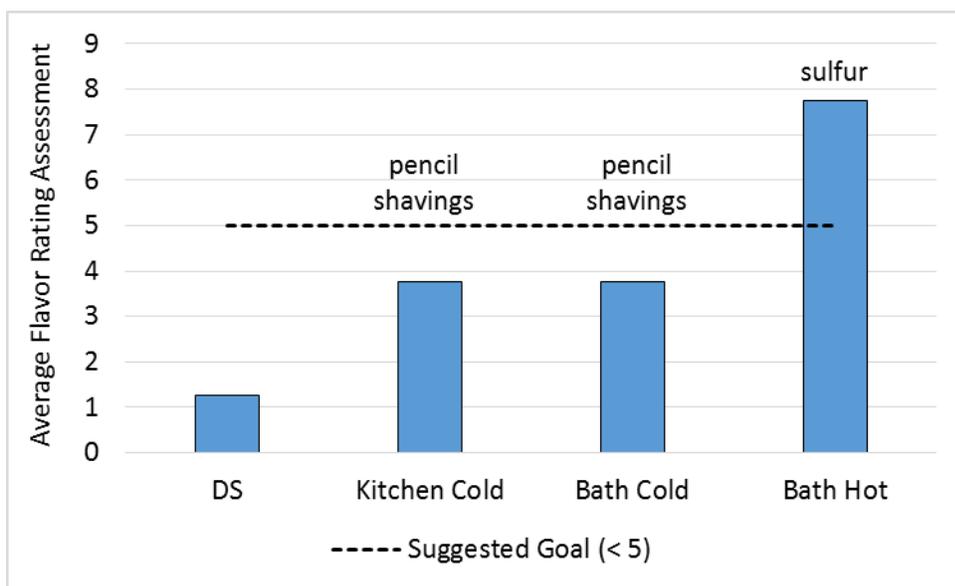
FRA data for Home A are presented in Figure 3. The distribution system water had the lowest average FRA score and no discernible odors or tastes were noted by the panelist performing the analysis, despite iron being greater than the secondary MCL and some evidence of microbial activity. Both the kitchen and bathroom cold taps had somewhat elevated FRA scores with a slight pencil shaving odor and taste. A pencil shaving taste and odor has been attributed to plastic pipe used for home plumbing, such as PEX used in both the homes included in this study. The hot water in the bathroom had a sulfur odor exceeding the threshold SPU considers unacceptable (*i.e.* average FRA ≥ 5). The sulfur odor would likely be objectionable to Longview residents.

Figure 3. FRA data for Home A.

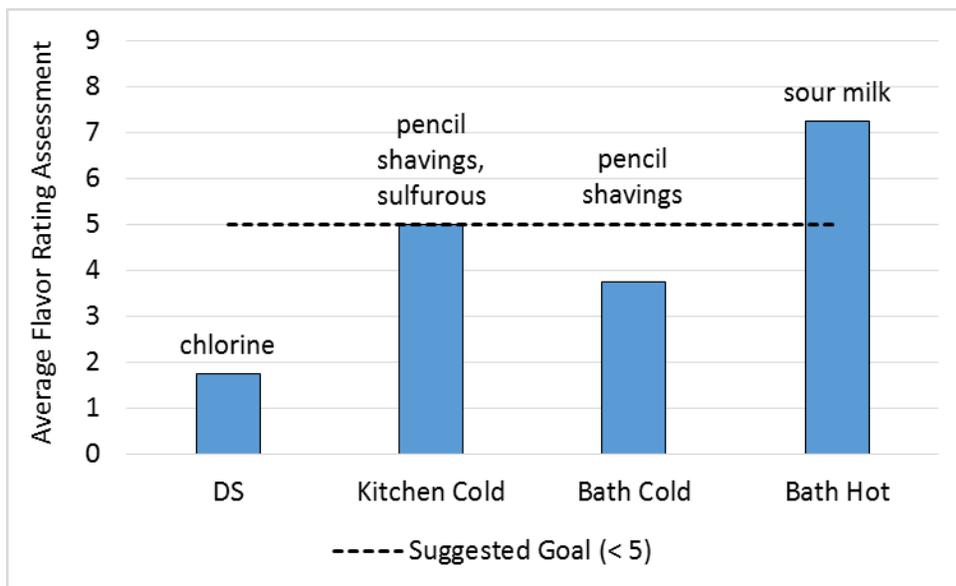
Average FRA scores for Home B are presented in Figure 4. The distribution system water had only a slight chlorine odor. Both the kitchen and bathroom cold taps had elevated objectionable odors including pencil shavings and sulfurous taste and odor. The hot water tap in the bathroom was the most objectionable with a sour milk taste and odor, possibly indicating elevated anaerobic microbiological activity occurring within the hot water tank. The FRA test is more sensitive with regard to the detection of sulfurous odors compared to the chemical analytical method, for which, sulfides were not detected in Home B (Tables 4 and 5).

Figure 4. FRA data for Home B.

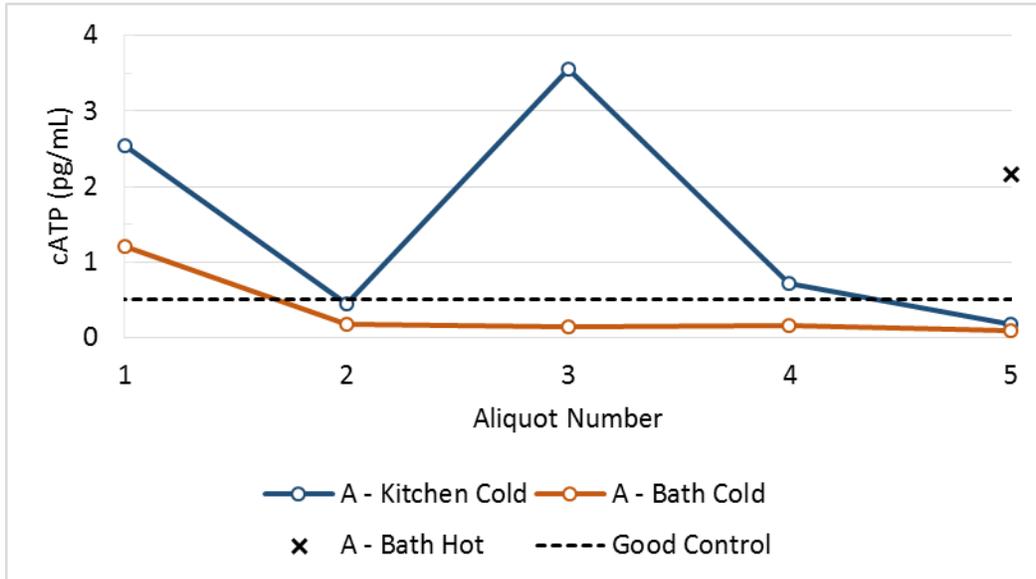
cATP data collected in Homes A and B are presented graphically in Figures 5 and 6, respectively. A level of 0.5 pg/mL or less is suggested by the cATP test kit vendor as representing good microbial control. The kitchen tap water and bathroom hot water had higher levels of cATP compared to the bathroom cold water tap for Home A. The lower levels of cATP in the bathroom cold tap may be a result of having drawn sufficient volume at the kitchen tap such that the water collected at the bathroom cold water tap was

likely at least a mix of fresh distribution system water, having a higher chlorine residual, with the water that had been standing in the premise plumbing. The lower chlorine residuals measured in both the distribution system and premise plumbing of Home A corresponded with higher cATP levels. Consistently running water at the tap appeared to improve water quality with respect to these two microbiological parameters for both homes.

Figure 5. cATP data for Home A.

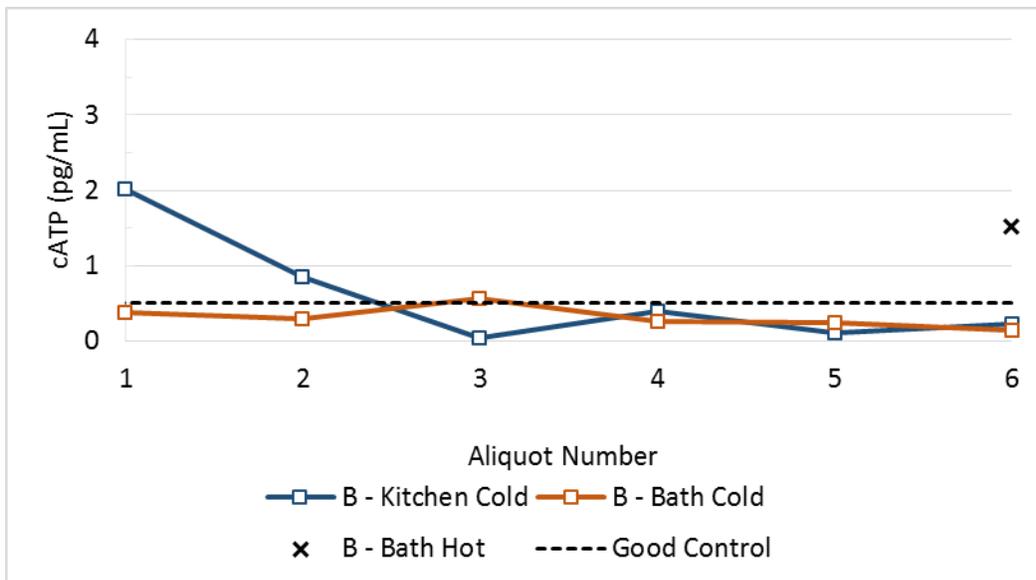
Figure 6. cATP data for Home B.

With regard to Home B, the kitchen tap had higher levels of cATP compared to the bathroom cold tap for the first two aliquots. Subsequent aliquots for the kitchen and bath cold taps had similar levels of cATP. The bathroom hot tap had a higher level of cATP than the bathroom cold tap. In general, cATP levels were

lower at Home B compared to Home A, likely due to the higher level of free chlorine residual in the distribution system at the time of sampling. Both homes had low chlorine residuals in the first several aliquots drawn from the kitchen tap. The elevated cATP and low chlorine residuals for the kitchen cold tap indicate growth of microbes in the bulk water and/or biofilm development within premise plumbing. If a biofilm forms within premise plumbing it would tend to cause an increase in the rate of chlorine residual decay.

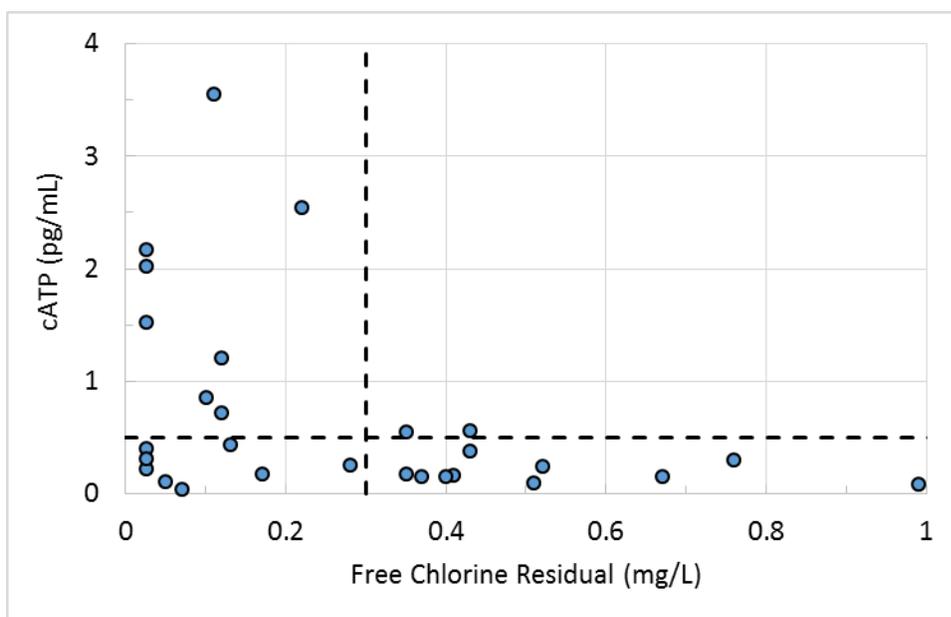
Figure 7 presents a compilation of all the cATP and free chlorine residual data collected in this study. When the free chlorine residual is above 0.3 mg/L corresponding cATP levels are generally ≤ 0.5 pg/mL, indicating good microbial control. When the free chlorine residual falls below 0.3 mg/L, cATP becomes more variable with the majority of the data points in excess of 0.5 pg/mL. Maintaining a free chlorine residual in the distribution system of at least 0.6 mg/L will likely help to increase the free chlorine residual within homes, which in turn, will likely help to control microbial growth within premise plumbing.

Figure 7. Correlation of cATP and free chlorine residual data.

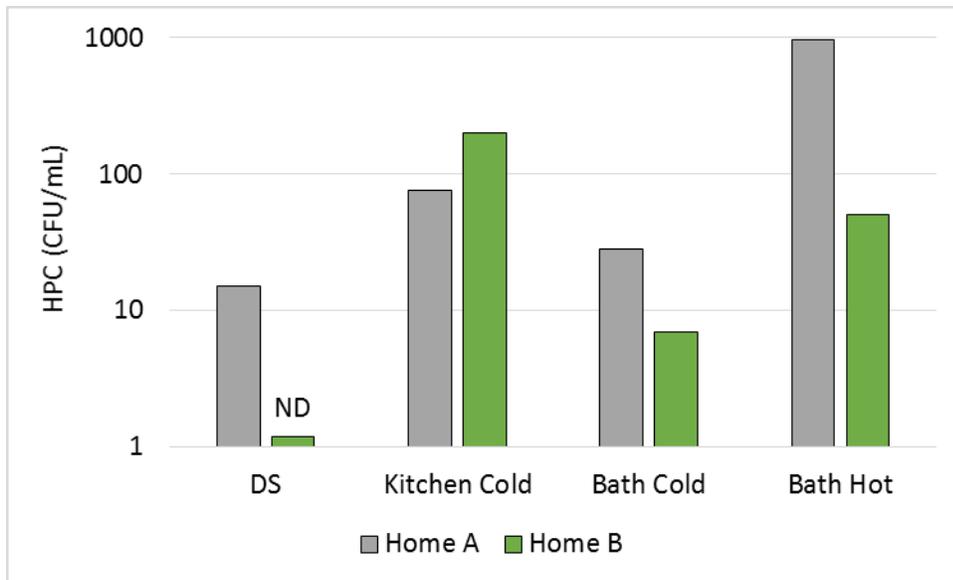
HPC data for Homes A and B are presented in Figure 8. Distribution system levels of HPCs were reasonably low at both sampling locations. The kitchen cold tap composite samples had HPC levels one to two orders of magnitude higher than in the distribution system. The bathroom cold tap composite samples were of the same order of magnitude as the corresponding distribution system samples. The HPCs in the bathroom hot water tap were two and one order of magnitude greater than the corresponding distribution system samples for Homes A and B, respectively.

Figure 8. HPC data summary.
